# RAVAS MANUAL FOR SERVICE TECHNICIANS

## INDICATOR 3200

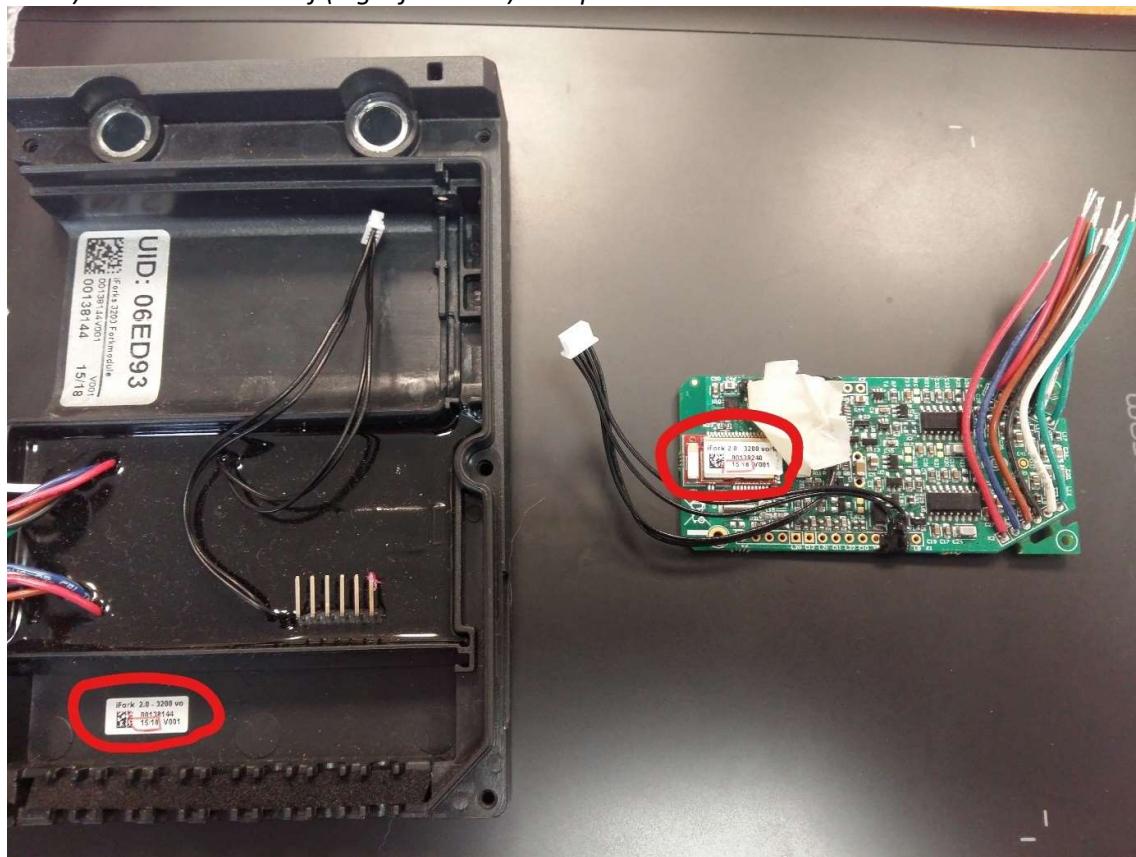
1. Bad or insufficient communication with the iForks (legal for trade and non legal for trade);

*In the first version of the hardware the PCB supplier used the wrong configuration for the PCB layers. This might cause problems with communication between the fork modules and the indicator. It is visible by checking the error log [GE] and look for errors (21/22/23 and 24). If the number of occurrences exceeds the value 1000, changing the fork modules is advised. There is no need for changing the modules if there are no communication problems! Modules from the first batch are marked with a small label inside the housing (non legal for trade) or on the PCB itself (legal for trade). See picture underneath.*

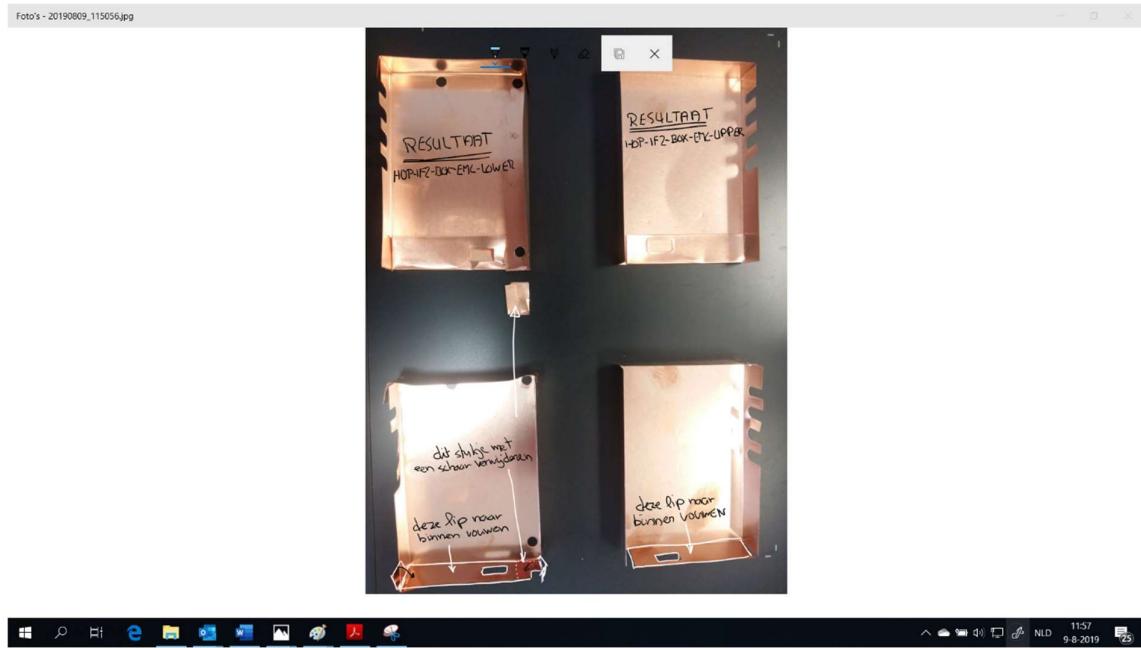
2. Bad or insufficient communication with the iForks (legal for trade);

*Bad communication with legal for trade units can also occur when the EMC protection is not according last version. In the first versions of this EMC housing the side at the BLE transmitter antenna was still present. In the new version this side is left out to get a better signal range. For older versions please fold down this side as shown in picture underneath.*

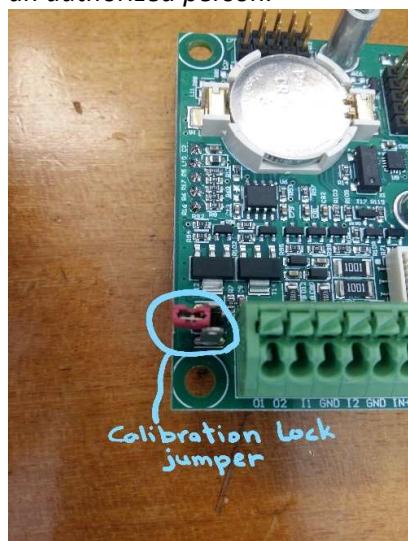
#### 9. [CAL-J] in the display

*This message will appear if the calibration jumper was placed and an attempt was made to re-calibrate the unit. The only solution for this is removing the calibration jumper. See picture underneath. Warning: if it concerns a legal for trade unit the sealing needs to be renewed by an authorized person.*

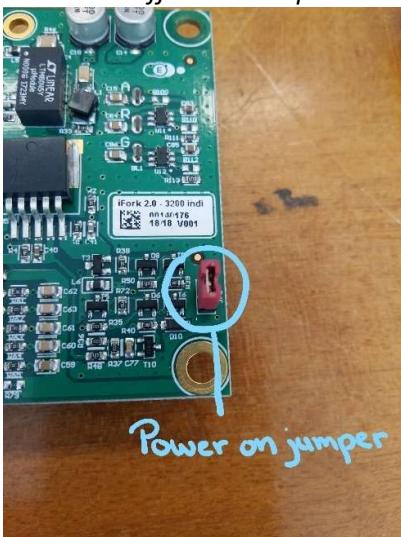
#### 10. Indicator turns on automatically after installing the battery

*This would be the case if the power on jumper was placed. To solve this removing the jumper would be sufficient. See picture underneath.*

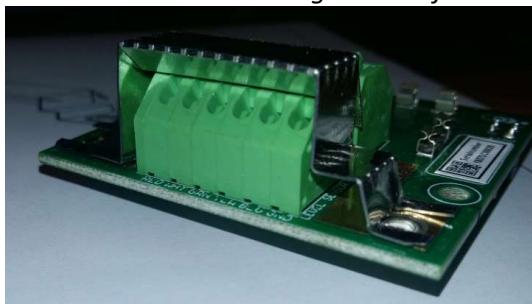
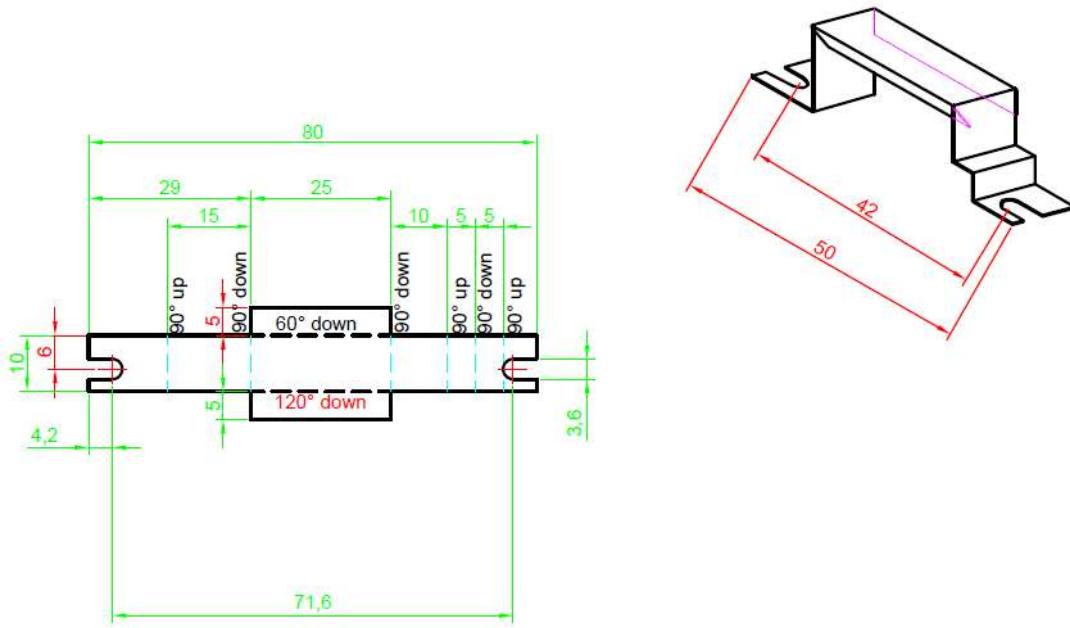
*This can be caused by a short-circuit at the 1AD board. The metal protection cover for the correction sensor might have scratched through the PCB surface making the shield short-circuit with the GND. Because the shield of the black legal for trade load cells is connected to the body of the load cell this creates a loop.*

*For a temporary solution remove the metal of the cover which is touching the GND surface.*

*10-8-2020: a new drawing is made for the cover which should prevent this in the future.*
